# Flathead County Transportation Plan – Phase II

## EXISTING TRANSPORTATION SYSTEM TECHNICAL MEMORANDUM

- PROBLEM IDENTIFICATION
- CRASH ANALYSIS
- INTERSECTION AND CORRIDOR CAPACITY ANALYSIS

June, 2009

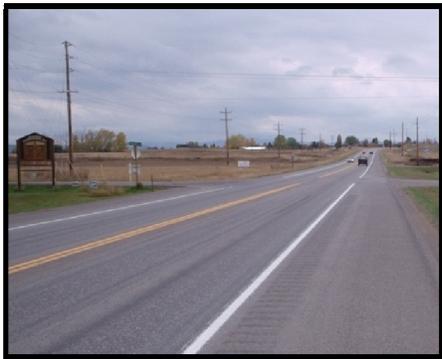
Photo 1: Highway 35 - Principal Arterial

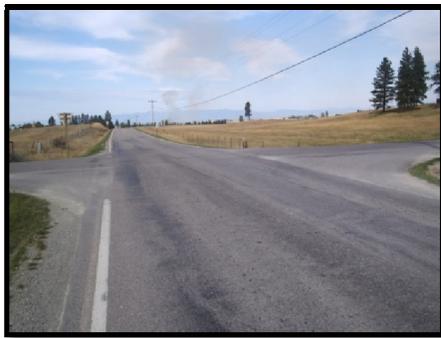
Photo 3: West Valley Drive - Major Collector

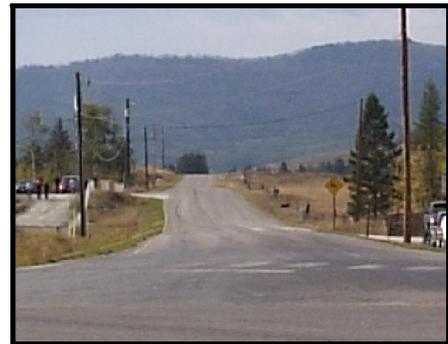
Photo 4: Batavia Lane - Minor Collector

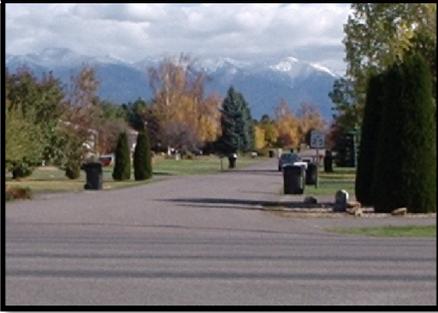
Photo 5: Winchester Street - Local / Subdivision Street

The subdivision road network provides direct access to residential, commercial or industrial lots, or other abutting lands, and connections to higher order systems. These roads typically service subdivisions and through-traffic movement is typically discouraged. Subdivision roads may be internal, located on the perimeter, or external to the subdivision. The minimum easement/right-of-way width for a subdivision road is generally 60 feet. The speed limit on subdivision roads is usually 25 mph or less.

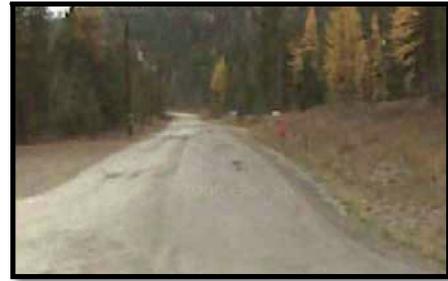
Photo 6: Ashley Lake Road

Ashley Lake Road was evaluated from the intersection with US Highway 2 north to the intersection of North Ashley Lake Road and Ashley Lake Road. Ashley Lake Road is a two-lane gravel roadway classified as a minor collector and has little to no shoulder. This roadway is used to access recreational areas around Ashley Lake in addition to serving residential areas along the corridor. The speed limit along Ashley Lake Road is 35 mph.

A speed study was conducted by RPA along Ashley Lake Road in August 2008, approximately 4.4 miles north of US Highway 2. The speed study showed an average speed of 35.9 mph and an 85<sup>th</sup> percentile speed of 42.8 mph. As the speed study shows, the average speed is close to the speed limit, while the 85<sup>th</sup> percentile speed is almost 8 mph higher than the posted speed limit. Generally it is desirable to have an 85<sup>th</sup> percentile speed within 5 mph of the posted speed limit. The high 85<sup>th</sup> percentile speed along Ashley Lake Road indicates that there may be a speeding problem at the study location.

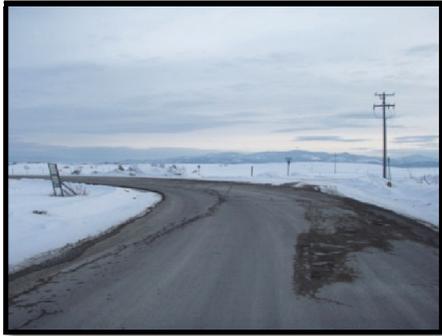
Photo 7: Church Drive

Church Drive was evaluated from the intersection with US Highway 93 west to the intersection with Bald Rock Road. Church Drive is a two-lane paved roadway classified as a minor arterial between US Highway 93 and Secondary 424 and as a minor collector west of Secondary 424. This corridor was not evaluated as part of the *Phase 1* plan.

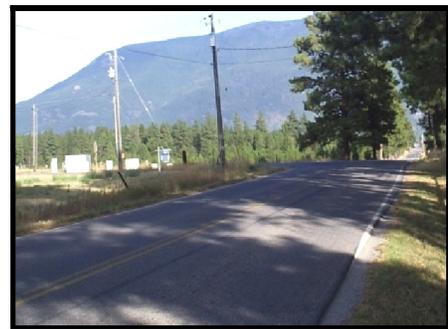
Photo 8: Columbia Falls Stage

This corridor was evaluated from the intersection US Highway 2 south to the intersection with MT Highway 35. River Road runs from the intersection with US Highway 2 southwest approximately 0.75 miles to intersect with Columbia Falls Stage; Columbia Falls Stage runs from the intersection with River Road south to intersect with MT Highway 35. The study corridor is a two-lane paved roadway classified as a major collector and is approximately 10.75 miles long.

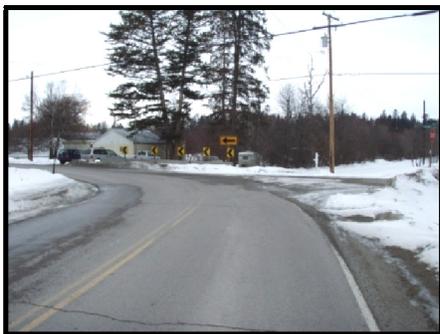
There were twenty-seven reported crashes along Columbia Falls Stage between January 1<sup>st</sup>, 2004 and December 31<sup>st</sup>, 2006. Sixteen of the twenty-seven crashes reported involved only one vehicle, the majority of which occurred along the shoulder of the roadway. Approximately half of the reported crashes occurred when the roadway surface was dry, while the remaining crashes occurred when the roadway surface conditions were poor (due to snow, ice, mud, or loose gravel). Ten reported crashes resulted in injuries, none of which resulted in fatalities.

**Photo 9:** Columbia Falls Stage / River Road

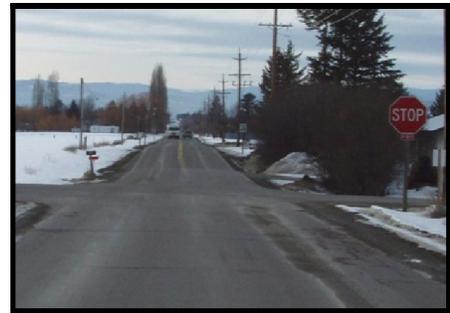
Photo 10: East Reserve / Helena Flats

East Reserve Drive was evaluated from the intersection with Helena Flats Road west to the intersection with US Highway 2. East Reserve Drive is a two-lane paved roadway classified as a minor arterial. There is a posted speed limit of 45 mph and little to no shoulder is provided along the corridor.

This corridor is approximately one mile long and serves multiple residential neighborhoods and businesses in the area. There are also three schools within a one-mile radius of East Reserve Drive. There are currently no sidewalks or bike lanes provided along the study corridor. Potentially hazardous conditions for pedestrians exist due to the high speeds along the corridor and the lack of pedestrian and bicycle facilities.

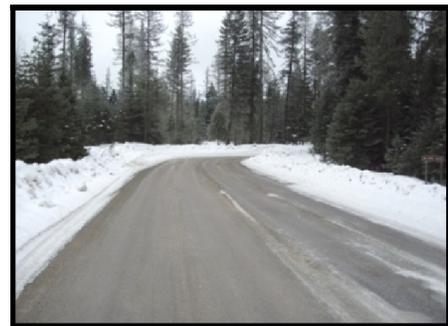
- ◆ **Intersection with Jewel Basin Road** – There were three reported crashes at this location. Jewel Basin Road intersects Foothills Road along a curve. There are sight distance issues, particularly southbound, at this intersection. The approach angle of Jewel Basin Road also adds to the dangerous conditions present at this location.

Photo 11: Foothills Road / Jewel Basin Road

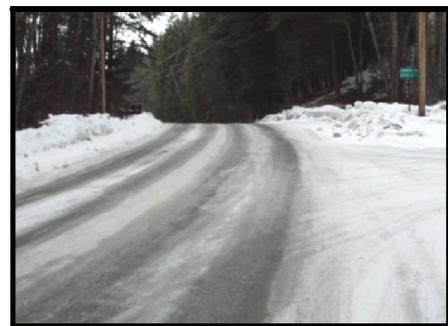
Photo 12: Snowberry Trail / Foothills Road

- ◆ **North of Snowberry Trail** – There were seven reported crashes along the one-mile stretch of Foothills Road north of Snowberry Trail. The majority of these crashes occurred just south of the last sharp curve along Foothills Road that heads to Lake Blaine Road. This stretch of Foothills Road generally has poor sight distances in addition to multiple sharp curves that lack appropriate signing.

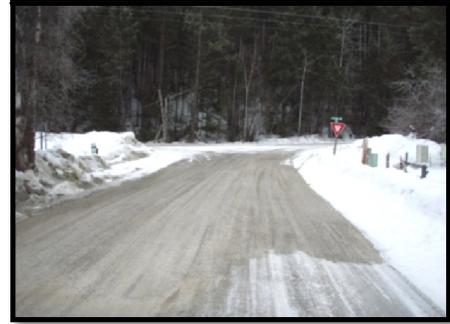
Photo 13: Bachelor Grade Road / Foothills Road

- ◆ **Peters Creek Way to Bachelor Grade Road** – There were four reported crashes along this one-mile stretch of Foothills Road. This stretch has multiple sharp curves with limited sight distance in addition to multiple approaches connecting to the corridor. Currently, a yield sign is provided along Bachelor Grade Road at the intersection with Foothills Road. The yield sign, coupled with the approach angle of Bachelor Grade Road, gives a false sense of priority to drivers accessing Foothills Road at this location.

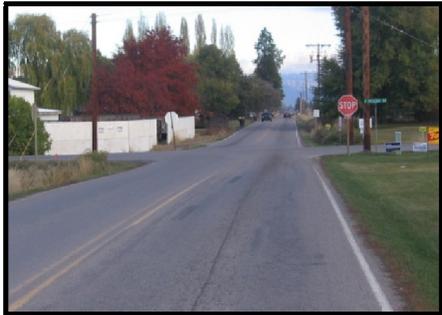
Photo 14: Helena Flats Road

Helena Flats Road was evaluated from MT Highway 35 north to East Reserve Drive. Helena Flats Road is a two-lane paved roadway with little to no shoulder and is classified as a minor arterial. This corridor serves local residents and connects Highway 35 to Highway 2 via East Reserve Drive. The study corridor has a posted speed limit of 35 mph.

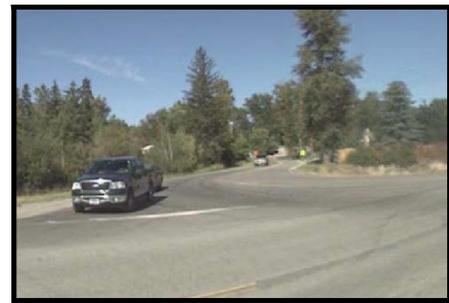
There were two reported crashes at the intersection with East Reserve Drive (see **Section 2.7.2** for more detail). Eight crashes occurred at the unsignalized intersection with MT Highway 35. This intersection is very wide and ill-defined. Also, southbound to eastbound drivers have a difficult time entering the traffic stream. This movement volume is increasing due to drivers avoiding LaSalle Road. Potential traffic signal control may be warranted as land use changes are proposed east of the Flathead River.

**Photo 15:** Helena Flats Road / MT Highway 35

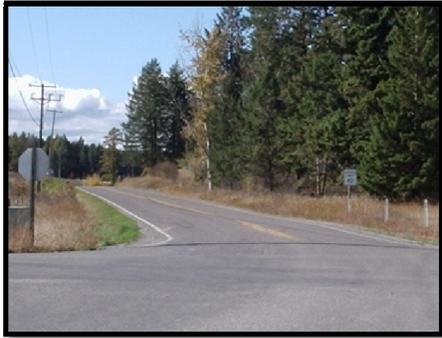
Photo 16: Hodgson Road / Whitefish Stage

Hodgson Road was evaluated from US Highway 93 to US Highway 2. Hodgson Road is a two-lane paved roadway with little to no shoulder and is classified as a major collector. The corridor serves local traffic and also serves as a connecting route between US Highway 93 and US Highway 2. The speed limit along Hodgson Road is 40 mph.

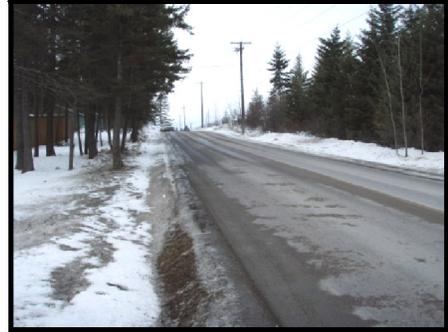
- ◆ **Hare Trail to Lidstrom Road** – There were ten reported crashes along this  $\frac{3}{4}$  mile section of Hodgson Road. This section of Hodgson Road is narrow and windy and has multiple residential access points and connecting roads, many of which have poor sight distance. The majority of these crashes occurred at intersections or along corners or hills where sight distance is limited. Seven crashes occurred when the roadway was icy or snowy. Three crashes resulted in injuries along this section of Hodgson Road.

Photo 17: Limited sight distances along Hodgson Road

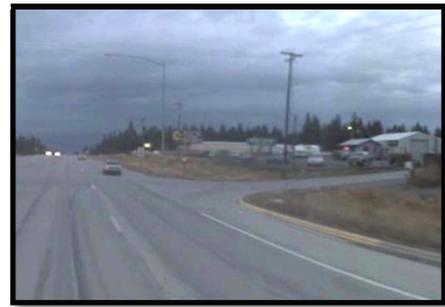
Photo 18: Hodgson Road / US Highway 93

- ◆ **Intersection with US Highway 93** – There were three reported crashes at this location, none of which resulted in injuries. This is a three-legged intersection with stop control along Hodgson Road. US Highway 93 has two travel lanes in each direction along with a center raised median. This intersection has some sight distance issues, particularly along the Hodgson Road leg. While traveling west along Hodgson Road, it is difficult to see this intersection due to the vertical curve present near the intersection. There is also no advanced warning sign for this intersection along Hodgson Road.

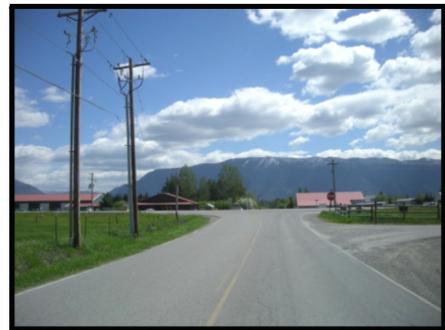
Photo 19: Hodgson Road / US Highway 2

- ◆ **Intersection with US Highway 2** – There were five crashes reported at this intersection. Of these crashes, all but one involved multiple vehicles. Three crashes resulted in injuries, one of which resulted in a fatality. US Highway 2 is a five-lane roadway consisting of two travel lanes in each direction and a two-way left-turn lane. This intersection does not appear to have sight distance or geometric configuration issues. It is expected that the high number of crashes occurring at this location are largely due to the high volume and large size nature of the intersection.

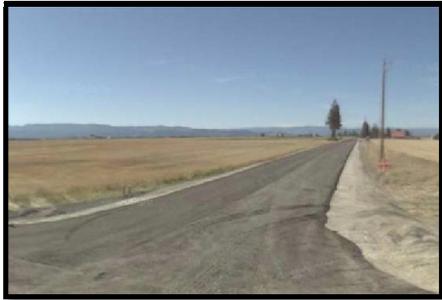
Photo 20: Holt Stage Road

Holt Stage Road / Mennonite Church Road was evaluated from Steel Bridge Road to Creston Hatchery Road. This corridor is a two-lane roadway that is paved along Holt Stage Road and gravel along Mennonite Church Road. This corridor serves local residents and connects the City of Kalispell to MT Highway 35. There is generally no shoulder provided and there are areas with steep side slopes. This corridor is classified as a major collector roadway with a speed limit of 35 mph. The area that the corridor serves is fairly undeveloped and consists mostly of fields and farmland.

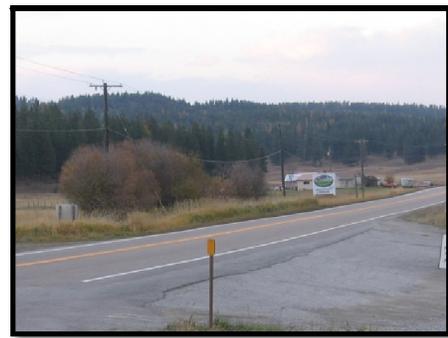
Kila Road was evaluated from the north intersection with US Highway 2 to the south intersection with US Highway 2. Kila Road has little to no shoulder and has multiple sharp curves, especially along the southern portion of the corridor. This is a two-lane paved roadway that serves the residents of Kila and surrounding areas. The roadway is classified as a major collector and has a speed limit of 35 mph.

Photo 21: Kila Road

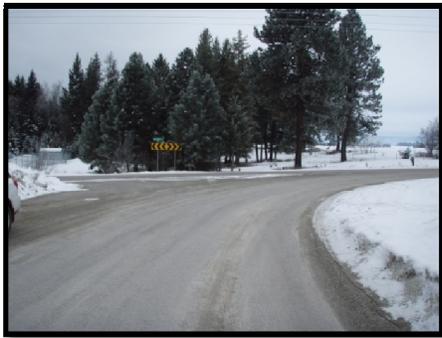
Photo 22: Lake Blaine Road / Foothills Road

Lake Blaine Road was evaluated from MT Highway 35 to the intersection with Hemler Creek Drive. Lake Blaine Road has little to no shoulder and has some sharp curves along its northern end which cause limited sight distance. This is a paved two-lane roadway that serves local residents and allows access to Lake Blaine. The speed limit along Lake Blaine Road is 45 mph from MT Highway 35 to Foothills Road, and 25 mph from Foothills Road to its end. Lake Blaine Road is classified as a major collector between MT Highway 35 and Foothills Road and as a minor collector from Foothills Road to its end.

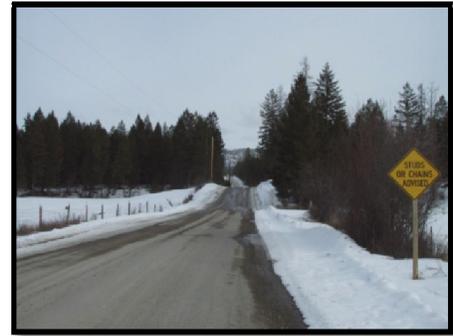
Spring Hill Road was evaluated from the intersection with Smith Lake Road to its end. Spring Hill Road is a two-lane gravel roadway with little to no shoulder. The road has several sharp curves and a portion of the roadway is on a steep vertical grade. This roadway serves residents along the corridor and also provides access to recreational areas in the area. The speed limit along Spring Hill Road is 35 mph and it is classified as a minor collector.

Photo 24: Spring Hill Road

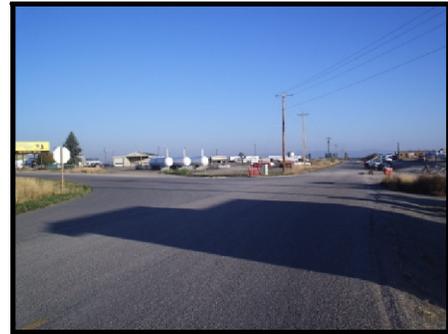
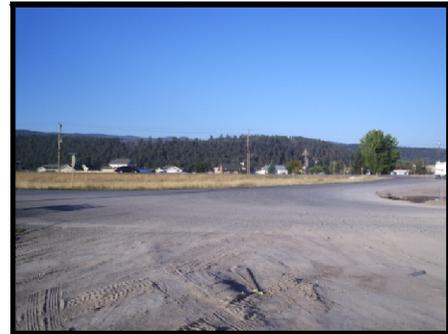
- ◆ Skewed and ill-defined
- ◆ Increasing ADT may create safety concerns

**Photo 25:** Auction Road / Demersville Road intersection; from top to bottom: Looking north; looking west; looking south.

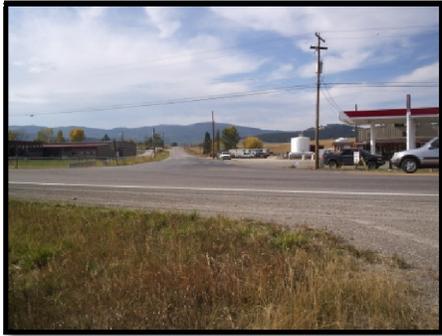
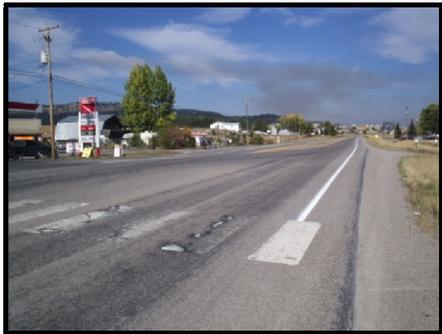
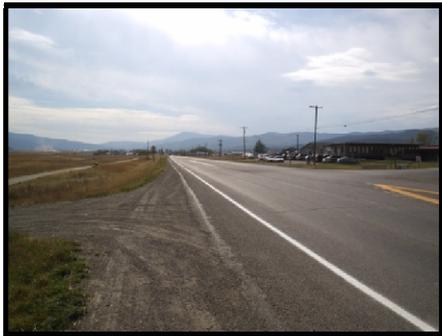
The intersection of Batavia Lane and US Highway 2 is located west of Kalispell. Batavia Lane is a paved two-lane roadway. US Highway 2 is a two-lane highway that serves regional and local traffic. This intersection is a skewed three-way intersection that has stop control along Batavia Lane. A northbound left-turn lane is provided along US Highway 2 at this location. A widened paved shoulder is provided along the southbound lane which serves as a right-turn lane. No striping currently exists designating this as a right-turn lane, however.

A gas station is located at the northwest corner and Smith Valley School is located along the southwest corner of this intersection. Painted crosswalks currently exist across the southern leg of US Highway 2 and across Batavia Lane. Crossing guards are used to help students cross US Highway 2 at this intersection. The speed limit along US Highway 2 is 45 mph in the adjacent school zone.

Two crashes occurred at this location during the three-year study period. Both crashes involved multiple vehicles and each resulted in non-incapacitating injuries. The LOS analysis completed for this intersection indicates a LOS of D for the AM peak hour and a LOS of C for the PM peak hour. It is expected that a large portion of the AM peak hour traffic is directly a result of the school located at this intersection.

**Photo 26:** Batavia Lane / US Highway 2 intersection; from top to bottom: looking west; looking north; looking south.

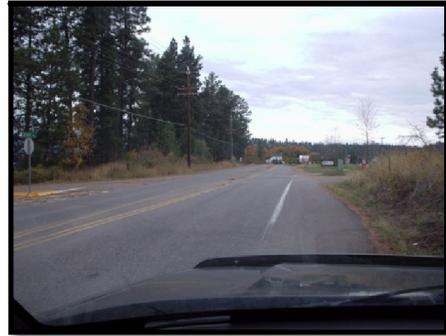
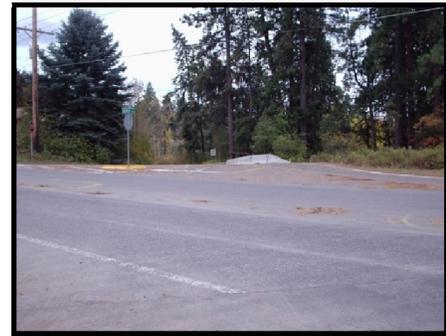
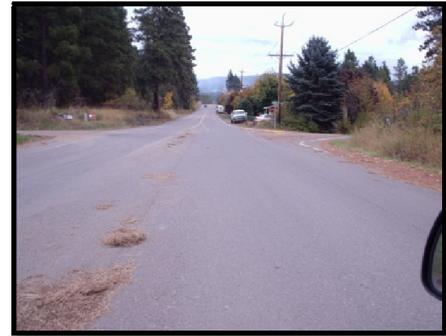
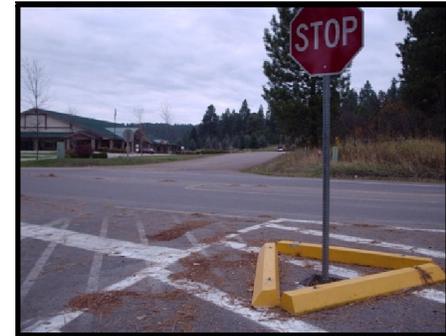
- ◆ Holt Drive is skewed and steep
- ◆ Separate right-turn lane divided by stop sign and curbing
- ◆ Limited sight distance
- ◆ Northern and southern approach alignment is poor

Photo 27: Beach Drive / Holt Drive intersection; from top to bottom: looking west; looking south; looking east; looking north.

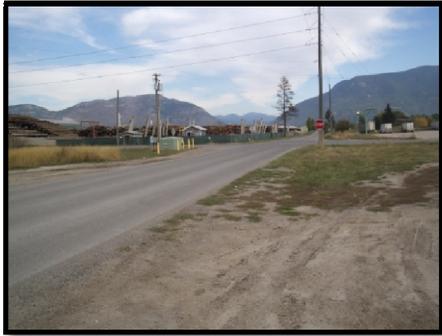
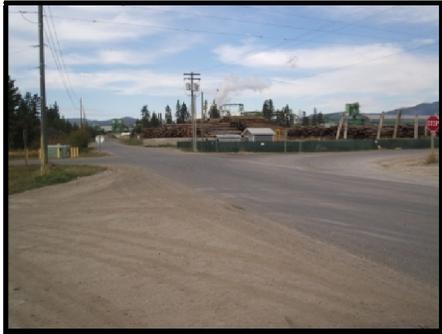
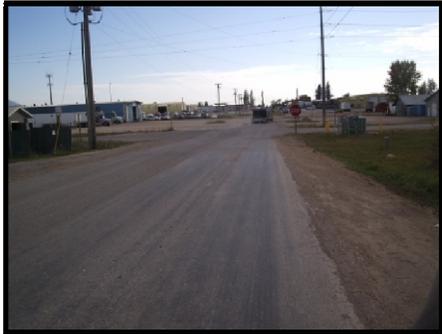
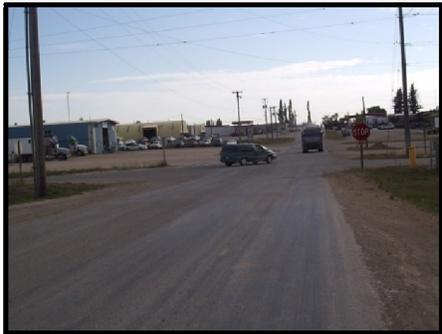
The intersection of Best Way and Truck Route is located along the western portion of Columbia Falls. Best Way and Truck Route are both two-lane paved roadways that mostly serve industrial and commercial businesses in the area. This intersection is a four-way stop-controlled intersection. A substantial number of large trucks utilize this intersection due to its close proximity to a logging mill and other businesses in the area.

No reported crashes occurred at this intersection during the three-year crash analysis period. The traffic volumes are currently low at this intersection, which result in a LOS of A for both the AM and PM peak hours.

This intersection presently functions at an acceptable LOS and does not appear to have safety issues resulting in high crash rates. An analysis of the current traffic volumes utilizing this intersection indicate that the volumes are fairly distributed along all four legs of the intersection. As traffic volumes increase, this intersection should be analyzed in more detail to determine if the stop control currently being provided along all four legs is still necessary, or if other traffic control measures are needed. It should be noted that the four-way stop-controlled intersection is the most restrictive form of intersection traffic control and often results in increased delay and vehicle emissions.

It is uncertain if all four corners of the intersection currently accommodate large trucks. Due to the high percentage of large trucks utilizing this intersection, it is important that the corner radii accommodate a large enough design vehicle.

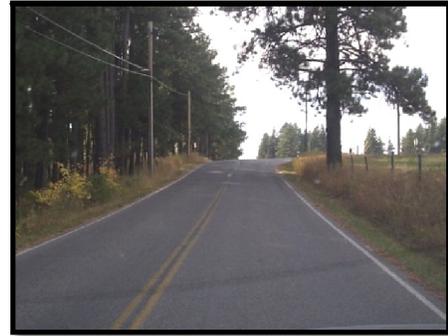
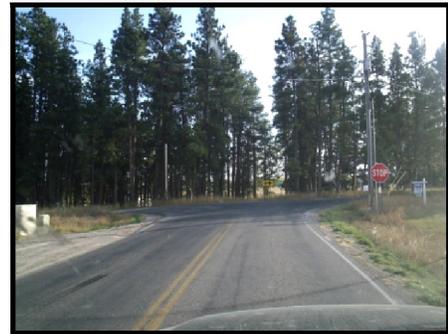
As development occurs in the area, and as traffic volumes increase, it is expected that this intersection will become more problematic due to the current geometric configuration and traffic control measures. Given the traffic distribution discussed above, it may be desirable to allow free flow traffic along Columbia Falls Stage Road. This could be achieved by realigning this intersection to create a smooth curve along the northwest corner (see illustration). The eastern leg of Kelley Road could then be realigned to connect to the intersection at a 90-degree angle. Stop control would then be provided along Kelley Road. Realigning the intersection in this fashion would allow for unobstructed movements for the majority of traffic. This will become increasingly important as traffic volumes increase at this intersection.

Photo 29: Columbia Falls Stage / Kelley Road Intersection; from top to bottom: looking west; looking south; looking east.

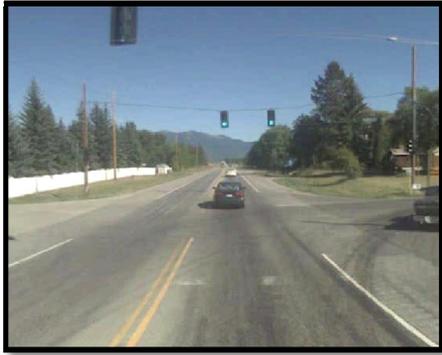
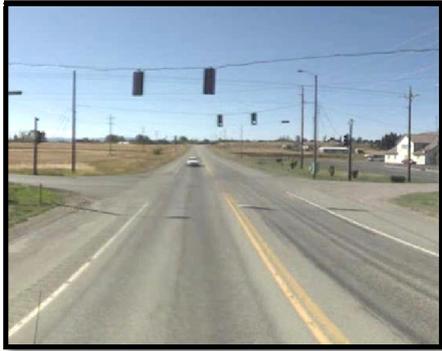
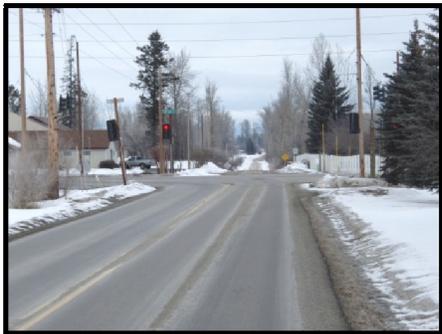
## 6. Fairmont Road and MT Highway 35

The intersection of MT Highway 35 and Fairmont Road is located east of Kalispell and east of the Flathead River. MT Highway 35 is a two-lane paved highway classified as a principal arterial. Fairmont Road is a two-lane paved minor collector roadway that serves local traffic. The intersection of MT Highway 35 and Fairmont Road is a four-way signalized intersection.

This intersection was recently temporarily signalized and the data collection at this location occurred while the intersection was unsignalized. Assumed signal timing was used for the performance analysis of this intersection and may not reflect actual signal timing. A LOS of B during the AM peak hour and a LOS of A during the PM peak hour resulted from this performance analysis. A previous analysis of this intersection under unsignalized conditions indicates a failing LOS during AM and PM peak hours.

The vast majority of traffic at this intersection occurs along MT Highway 35. Turn-lanes are not currently provided along any of the intersection legs. As traffic volumes increase, turn lanes off of MT Highway 35 may be needed.

There were four crashes at this location during the three-year crash analysis period. The crash analysis period occurred while the intersection was unsignalized. Two of these crashes resulted in injuries. It is unknown how the safety of this intersection has changed since its recent signalization.

MT Highway 35 has a speed limit of 65 mph at this location, which could result in potentially hazardous situations at this location. Advance intersection warning signs may be needed to help identify the traffic signal along this high-speed highway

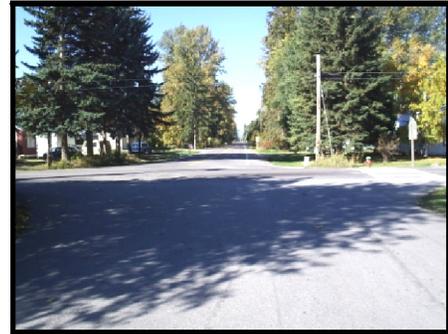
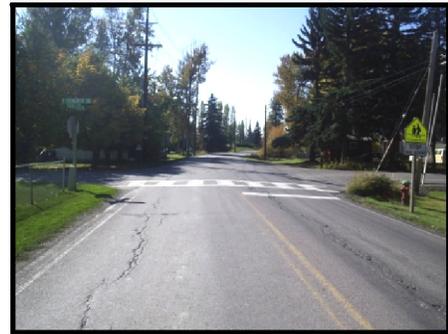
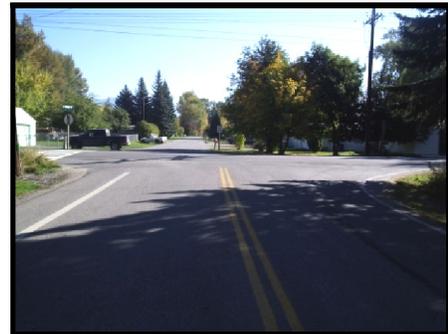
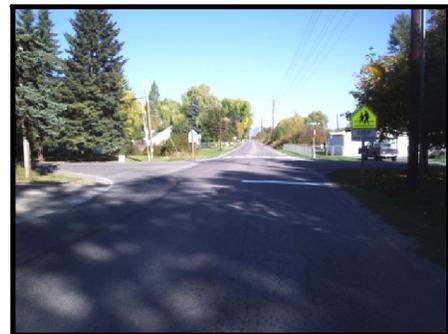
**7. Helena Flats Road and East Evergreen Drive**

The intersection of Helena Flats Road and East Evergreen Drive is a four-legged intersection with stop control along East Evergreen Drive. East Evergreen School is located along East Evergreen Drive near the intersection with Helena Flats Road. A crosswalk is provided across the northern leg of this intersection.

There were two reported crashes at this intersection during the three-year study period. Both crashes involved two vehicles, one of which resulted in a non-incapacitating injury. A LOS analysis completed for this intersection shows that it currently functions at a LOS of B during AM and PM peak hours. The vast majority of traffic occurring at this intersection occurs along Helena Flats Road as straight through movements. One concern regarding this intersection is the amount of vegetation present at the corners of the intersection. Care should be taken to trim vegetation so that sight distance and traffic control signs are not obstructed.

It is expected that this intersection, particularly along Helena Flats Road, will see an increase in traffic volumes due to its use as a “bypass” to LaSalle Road / US Highway 2. At this time, the intersection functions adequately; however, if traffic volumes increase, or traffic patterns change, this intersection should be analyzed in more detail to determine if a change in traffic control devices, or the addition of turn-lanes, may be needed.

- ◆ Majority of intersection traffic occurs along Helena Flats Road
- ◆ Vegetation obstructs sight distances and/or traffic signs
- ◆ East Evergreen School is located near the intersection
- ◆ Increasing use as a “bypass” to LaSalle Road / US Highway 2
- ◆ Likely increasing ADT may result in intersection performance issues

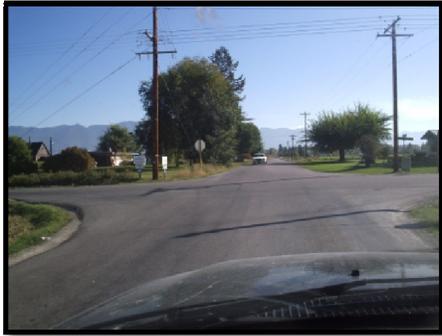
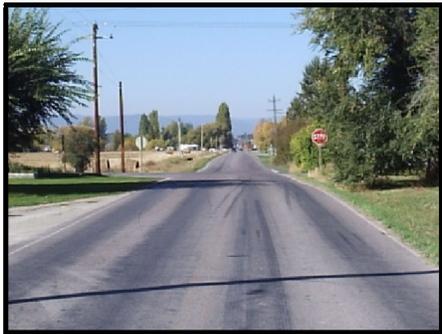
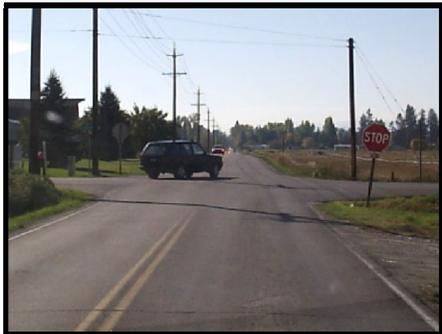
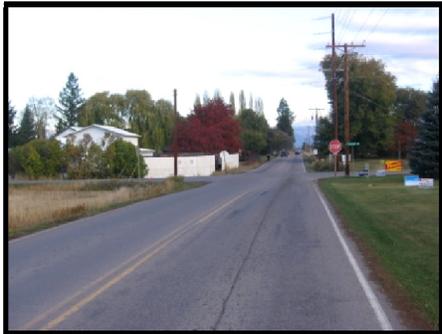
**Photo 32:** Helena Flats Road / East Reserve Drive; from top to bottom: looking east; looking west; looking south; looking north.

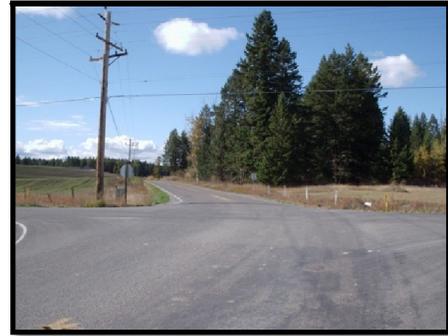
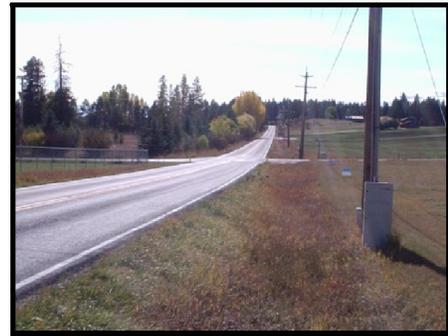
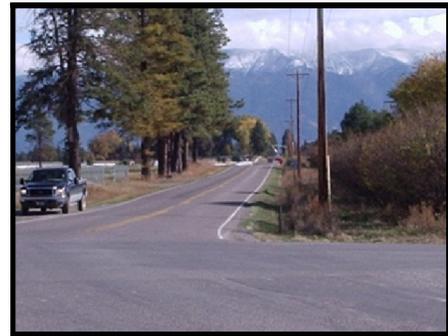
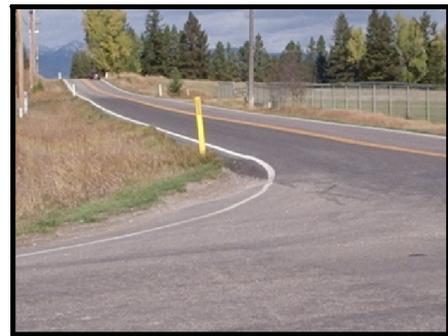
**Photo 33:** Hodgson Road / Whitefish Stage; from top to bottom: looking west; looking south; looking east; looking north.

The intersection of Hodgson Road and Whitefish Stage is a four-legged intersection with stop control along Hodgson Road. Six crashes were reported at this intersection during the three-year study period. Of the six crashes, two resulted in injuries, none of which were incapacitating. The intersection has a crash rate of 1.69 crashes per million entering vehicles. This intersection had the highest number of crashes and the second highest crash rate of the study intersections over the three-year analysis period.

A performance analysis completed for this intersection indicates that the intersection performs at a LOS of B during the AM and PM peak hours. The traffic volumes are fairly evenly distributed along all four intersection legs. No proportionally heavy traffic movements are apparent at this intersection.

The main concern with this intersection is the skewed western approach leg. The geometrics of this leg are awkward and restrict sight distance which results in safety issues. The high number of crashes occurring at this intersection may at least partially be attributed to the poor intersection alignment.

- ◆ High rate of crashes
- ◆ Skewed western approach leg
- ◆ Limited sight distance

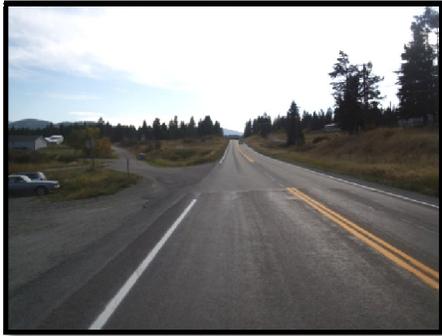
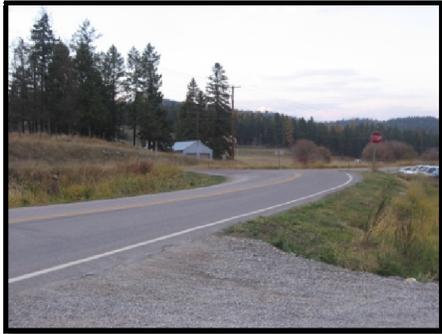
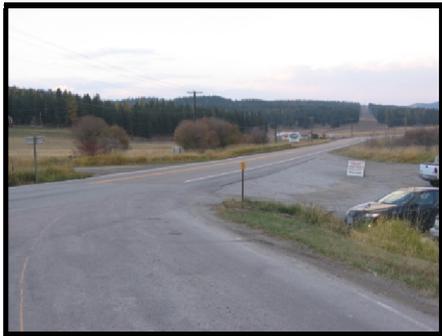
## 10. Kila Road and US Highway 2

The intersection of Kila Road and US Highway 2 is a three-legged intersection with stop control along Kila Road. This intersection is very skewed and as a result has limited sight distance. Five crashes were reported at this location during the three-year analysis period. Of the five crashes, three resulted in injuries, none of which were incapacitating. This intersection had the third highest number of crashes and the third highest crash rate of the study intersections.

A performance analysis of this intersection shows that the intersection functions at a LOS of B during the AM peak hour and at a LOS of A during the PM peak hour. A look at the turning movement counts performed at this intersection shows that almost all of the traffic accessing US Highway 2 at this location is turning right off of Kila Road. The counts also show that almost all of the traffic accessing Kila Road from US Highway 2 at this location is turning left from US Highway 2.

An initial look at the “Volume Guidelines for Left-Turn Lanes at Unsignalized Intersections on 2-Lane Highways” contained in MDT’s *Traffic Engineering Manual* indicates that a southbound left-turn lane should be considered at this location based on current traffic volumes. Currently, vehicles stopping to turn left onto Kila Road are interrupting US Highway 2 traffic flow.

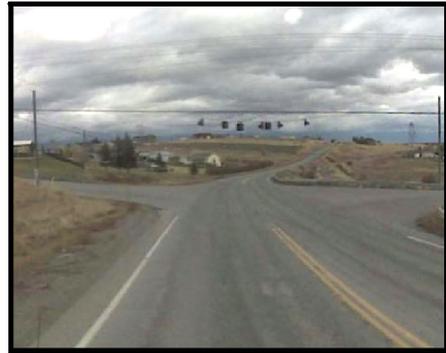
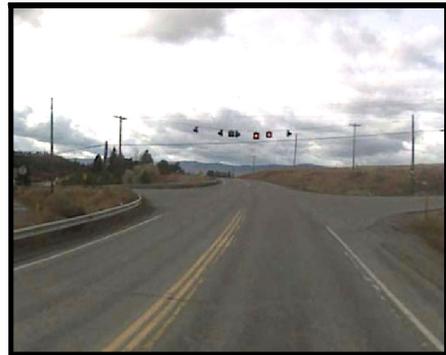
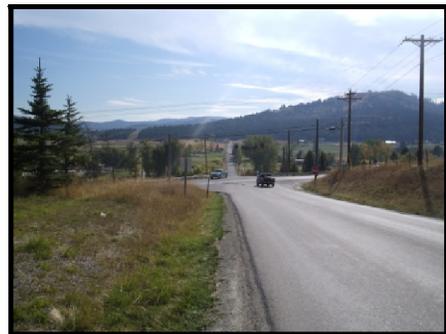
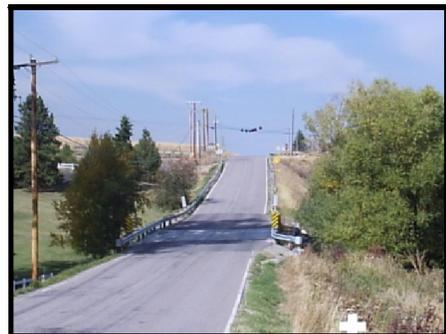
- ◆ Highest composite crash rating
- ◆ Limited sight distance along southwestern corner
- ◆ Failing LOS during AM and PM peak hours
- ◆ Preliminary signal warrant analysis indicates a signal may be warranted
- ◆ High percentage of truck traffic
- ◆ Steep grade along Dern Road

Photo 35: West Springcreek Road / US Highway 2; from top to bottom: looking east; looking west; looking south; looking north.

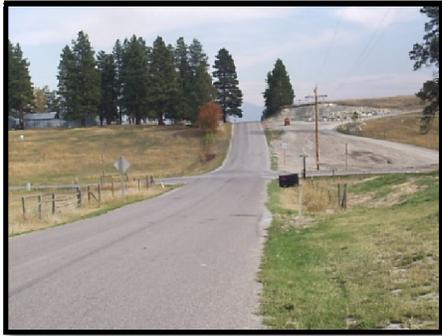
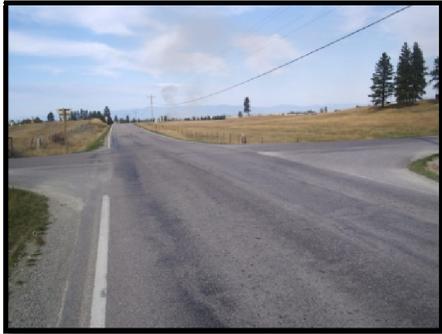
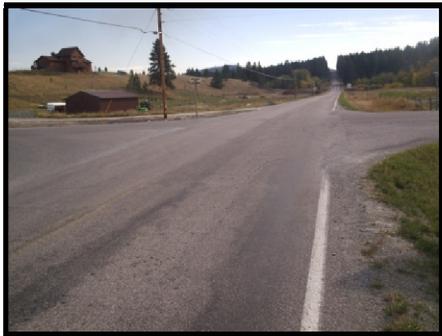
Photo 36: West Valley Drive / Three Mile Drive; from top to bottom: looking east; looking south; looking north.

This intersection is a four-legged intersection with yield signs along West Valley Drive. There have been three reported crashes at this intersection during the three-year analysis period. Two of the crashes resulted in injuries, none of which were incapacitating. This intersection has the highest crash rate and fourth highest severity index, resulting in the second highest composite rating among the study intersections.

The performance analysis conducted for this intersection indicates that it functions at a LOS of A during both the AM and PM peak hours. A look at the traffic patterns indicate that a vast majority of the traffic entering this intersection occurs along West Valley Drive. It would seem better suited to move the traffic control signs from West Valley Drive and place them along the Three Mile Drive approaches.

In general this intersection performs quite well. There is minimal traffic delay and the sight distance seems adequate along all corners. Despite the low traffic volumes and minimal delay, this intersection did have a high crash rate resulting in 1.92 crashes per million entering vehicles. This high crash rate may at least partially be due to the traffic control signs being placed along the higher volume legs of the intersection instead of being placed along the lower volume legs. This may cause confusion amongst users resulting in unsafe conditions.

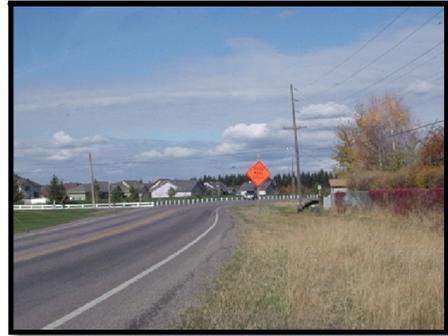
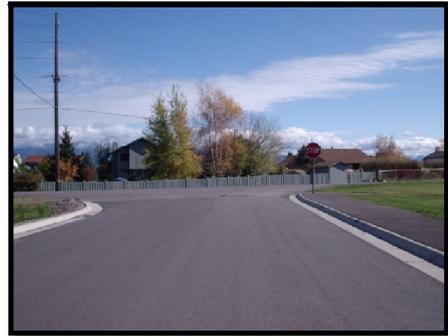
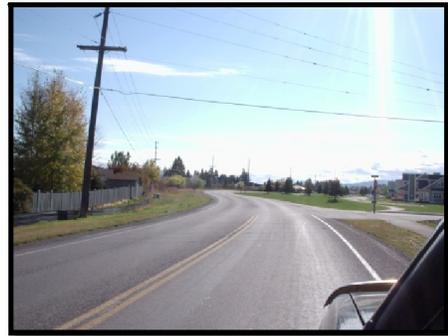
- ◆ One incapacitating injury occurred during the analysis period
- ◆ Lack of treatment for the shared-use path crossing
- ◆ Turn lanes off of Whitefish Stage may be needed in the future

Photo 37: Whitefish Stage / Granrud Lane; from top to bottom: looking north; looking east; looking south.

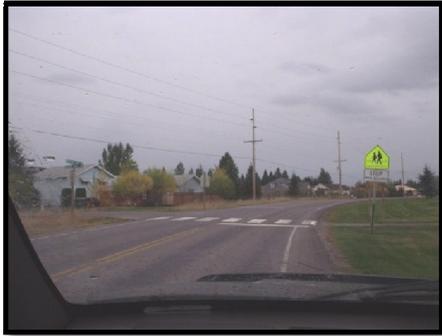
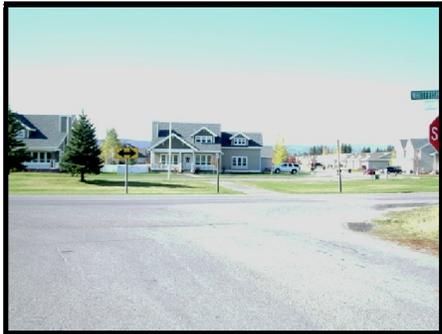
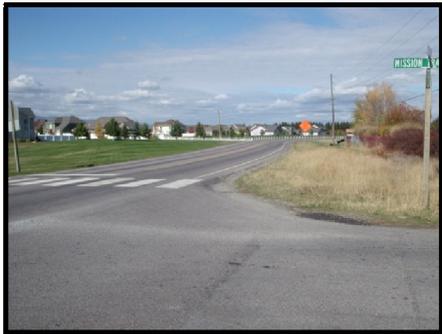
Photo 38: Whitefish Stage / Mission Trail; from top to bottom: looking south; looking west; looking north.

This intersection is a three-legged intersection with stop control along Mission Trail. There were no reported crashes during the three-year analysis period. A performance analysis of this intersection indicates that the intersection performs at a LOS of C during the AM and PM peak hours. The vast majority of the vehicles traveling along Mission Trail are turning left at the intersection to head south towards Kalispell. Similarly, the majority of vehicles turning onto Mission Trail are right-turns off of Whitefish Stage.

Overall, this intersection performs adequately for the amount of traffic that it handles. The relatively limited use along Mission Trail contributes to the high performance level of the intersection. This intersection is geometrically sound and has good sight distance in all directions. If traffic volumes continue to rise in the future, this intersection should be monitored to determine if turn lanes off of Whitefish Stage are justified. In the future, as the LOS decreases, additional traffic control device may be needed.

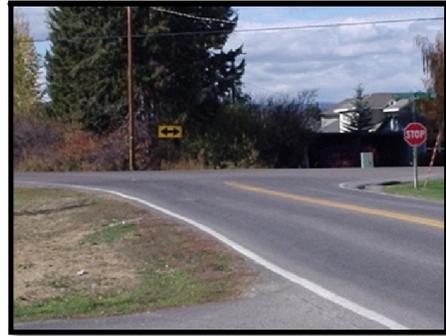
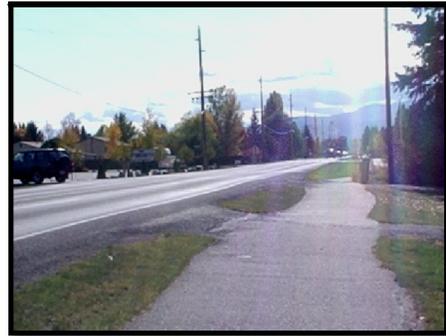
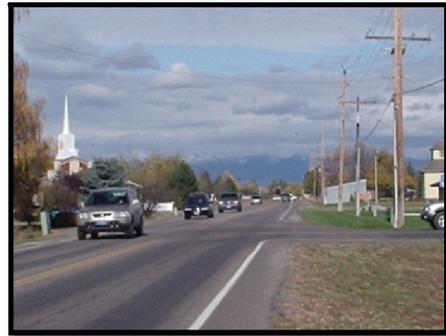
- ◆ Poor PM peak hour LOS
- ◆ High volume of vehicles turning from Whitefish Stage
- ◆ Preliminary signal warrant analysis indicates a signal may be warranted
- ◆ School and area businesses located nearby

Photo 39: Whitefish Stage / West Evergreen Drive; from top to bottom: looking west; looking south; looking north.

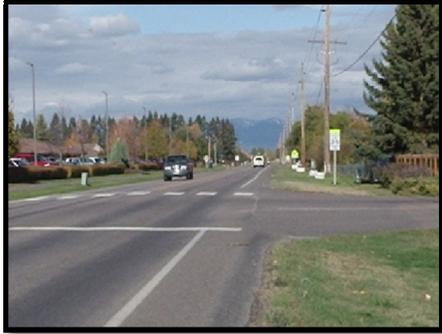
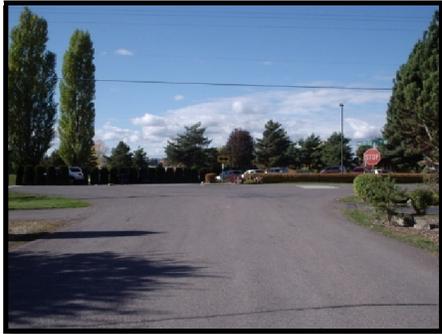
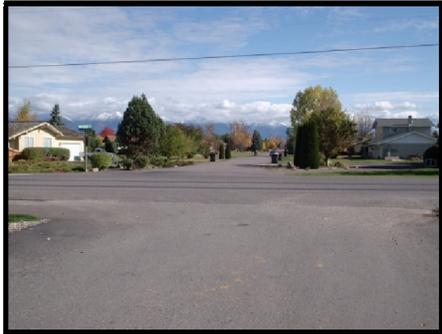
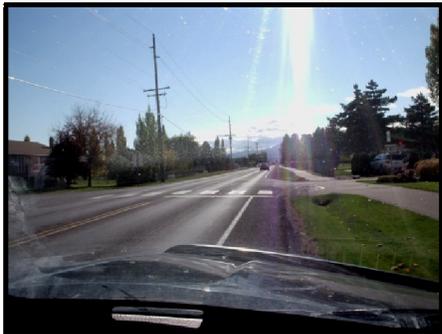
**Photo 40:** Whitefish Stage / Winchester Street; from top to bottom: looking north; looking west; looking east; looking south.

This intersection is a four-legged intersection with the western leg being an access to the Buffalo Hill Golf Club. Stop control is provided along the Golf Club access road and along Winchester Street. There were no reported crashes during the three-year analysis period. A performance analysis of this intersection indicates that the intersection performs at a LOS of C during the AM and PM peak hours.

Overall, this intersection performs adequately for the amount of traffic that it handles. If traffic volumes continue to rise in the future, this intersection should be monitored to determine if turn lanes or other traffic control measures are justified. Another concern regarding this intersection is that there is no signing for the crosswalk across the northern leg of the intersection. This may reduce the visibility of the crosswalk to oncoming motorists.

- ◆ No signing for the crosswalk across Whitefish Stage
- ◆ Increasing traffic volumes may necessitate additional traffic control measures
